A Fast-Curing Metal Repair Composite for High Speed Emergency Repairs

Belzona 1221 (Super E-Metal) is a two component emergency repair composite based on a ceramic steel reinforced polymer system. This fully machinable Belzona product can be used for the permanent bonding, repairing or rebuilding of metallic components.

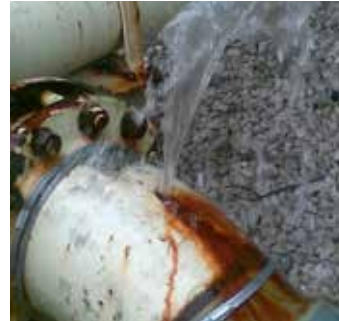
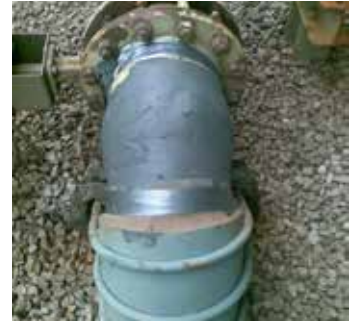
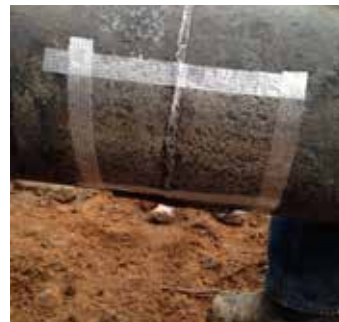
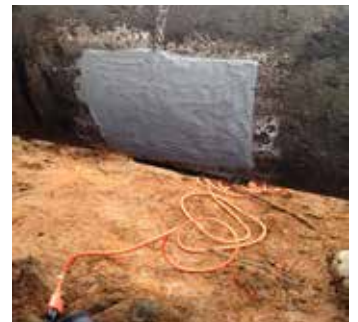
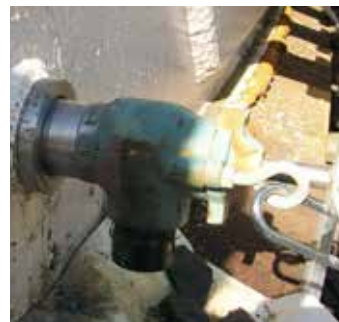
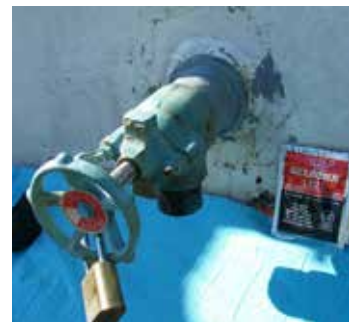
Application: Before & After

- Leaking pipes
- Scored hydraulic rams
- Leaking tanks
- Stripped threads
- Fractured and holed casings
- Bearing seats
- Damaged insulators
- Ducts
- Hoppers
